LIVESTOCK INSPECTION DIGITAL PHOTOGRAPH PHOTOCOPIES

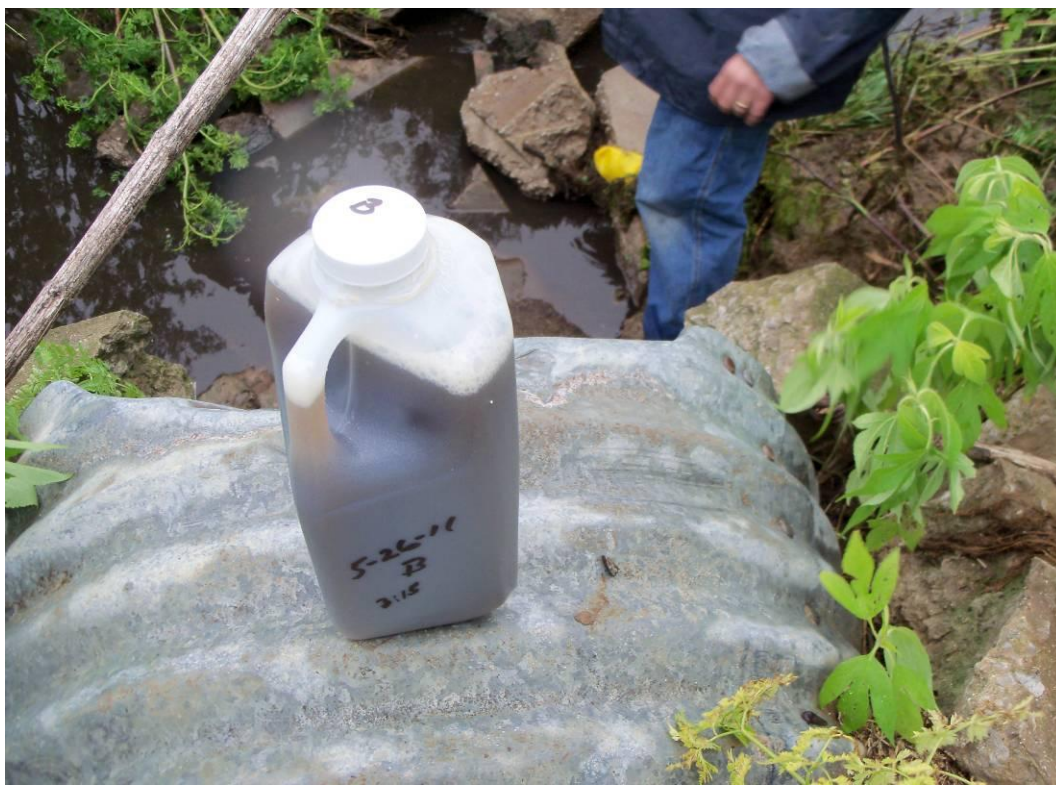
Photo # 026
Date: May 26, 2011
Time: 3:23 p.m.
Taken By: Brian Rodely DWPC/FOS
Facility: Elm Farms, Inc.
Location: W of Bottom Prairie Rd.
Notes: This is a photo of culvert where Sample B was collected. Note the dark appearance of the sample.

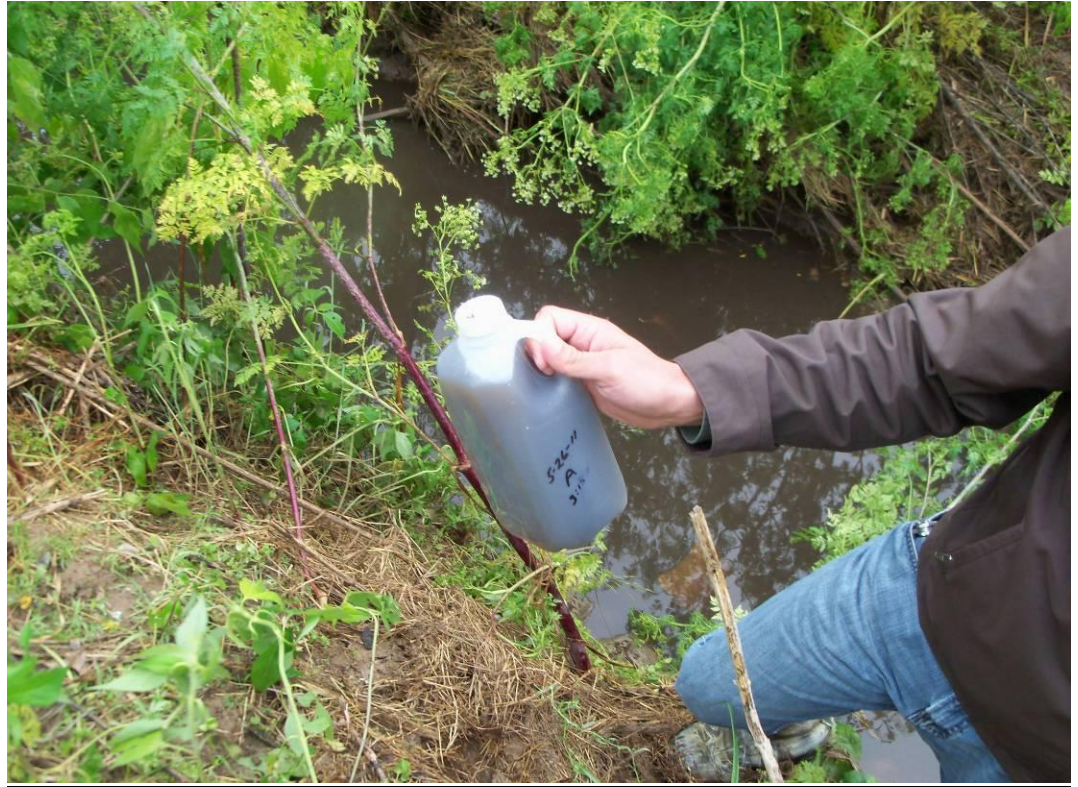
Photo # 027
Date: May 26, 2011
Time: 3:26 p.m.
Taken By: Brian Rodely DWPC/FOS
Facility: Elm Farms, Inc.
Location: W of Bottom Prairie Rd
Notes: This is a photograph of
location where Sample A
was collected. Note the
dark appearance of the
sample.
